Inspection Report

New Construction Home

PROPERTY INSPECTION REPORT

Concerning: New Construction

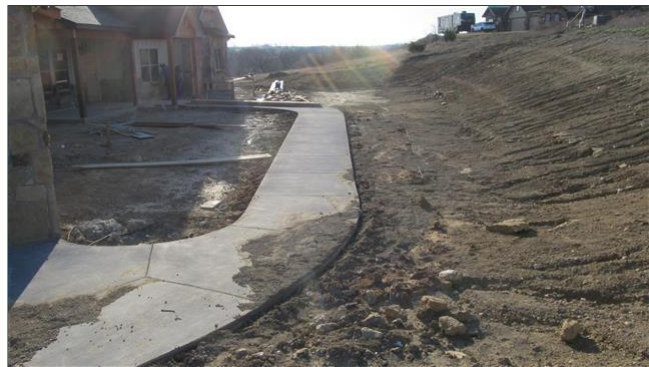
B. Item 1(Picture)

(1) At the time of the inspection, the grading was not completed for front or back yard and water supply line and electrical conduit for rear electric was not covered. Recommend a re-inspect after final grading and drainage is complete.

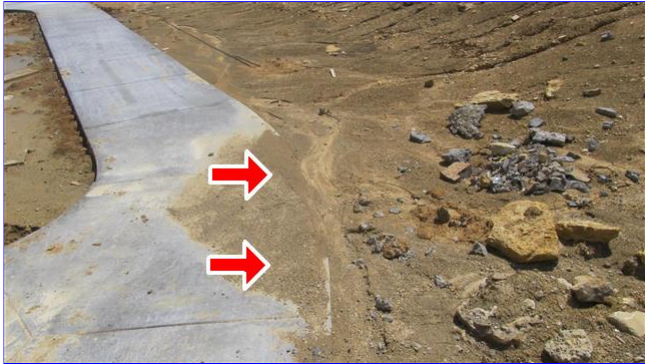
B. Item 3(Picture)

The final grading was still not completed at the time of the inspection. Inspector observed dirt silt on front walkway and areas that had water from last rain. These areas may need additional drainage such as french drains to prevent excessive moisture around foundation and erosion.

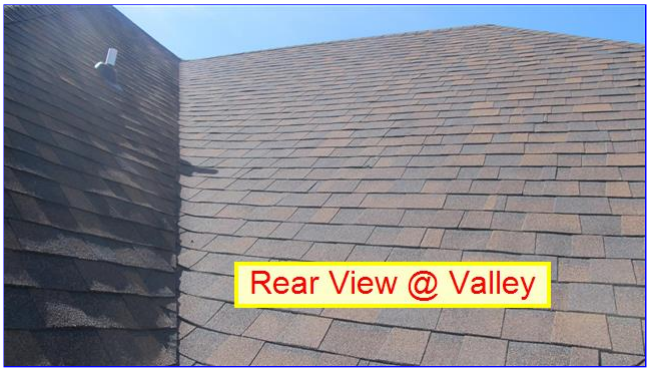
C. Item 7(Picture)

(2) The roof moisture barrier at the top of the valley above the garage had roofing nail hole. The inspector is not able to tell if this condition will cause a leak due to no rain. Recommend monitor area and repair if needed.

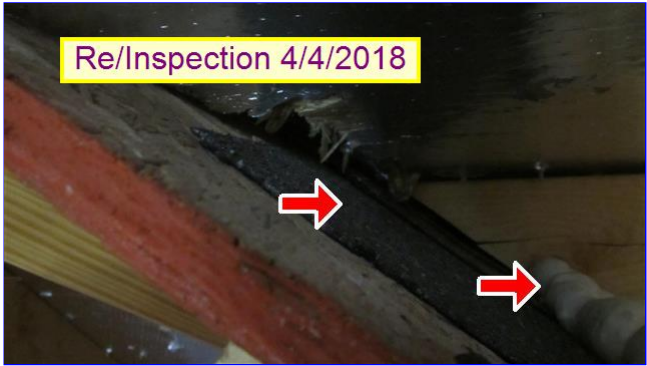
D. Item 5(Picture)

(2) There are areas of the bonus room (upstairs) where the roof design was changed which caused the rafters to not have adequate support. These areas will need additional support beams and columns to prevent a structural failure. Recommend a qualified construction contractor evaluate and repair area for support.

The Rafters in this area were still unsupported and may not hold the weight of the roof valleys. This area should be evaluated by a structural engineer.

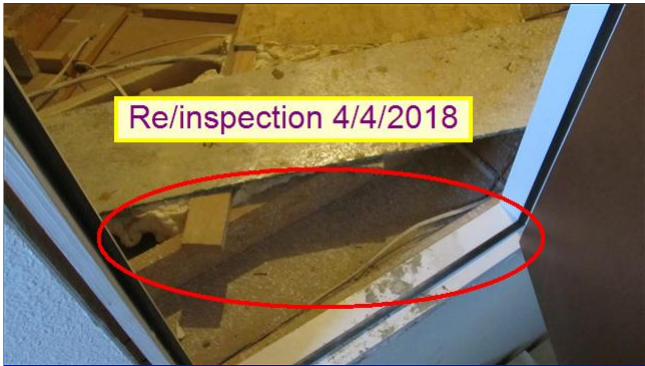
D. Item 12(Picture)

(4) The attic passageway (platform) to furnace and HVAC air handler is not finished and is a hazard. Recommend the platform be extended all the way to the edge of the attic access door.

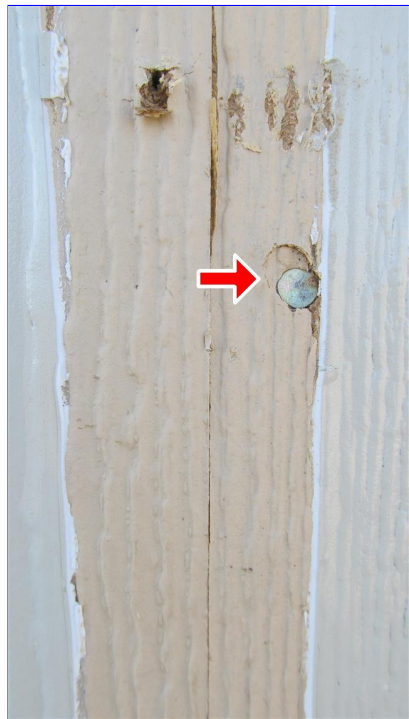
E. Item 4(Picture)

(3) The vertical wood siding was fastened with what appeared to be wood and cement fiber stainless steel

ring shank siding nails which is a permissible type of fastener that can be used. The manufacturer does not specify that screws should be used at joints for stability.

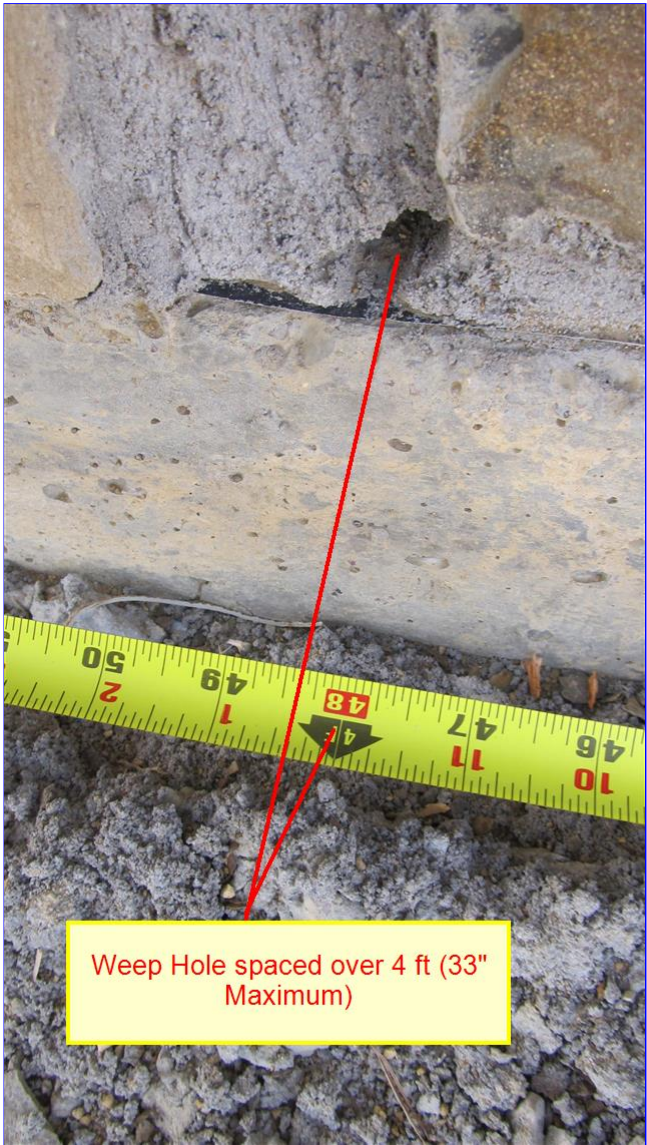
E. Item 9(Picture)

areas around the home. IRC requires weep holes to be no more than 33" apart. Recommend a qualified mason unblock existing weep holes for proper drainage and add weep holes to maintain 33" requirement.

Some weep holes had been installed but there were still areas with over 6ft spans without weep holes. These areas may not drain moisture properly. Recommend repair by qualified person.

R703.8.6 Weepholes.
Weepholes shall be provided in the outside wythe of masonry walls at a maximum spacing of 33 inches (838 mm) on center. Weepholes shall be not less than $\frac{3}{16}$ inch (5 mm) in diameter. Weepholes shall be located immediately above the flashing.

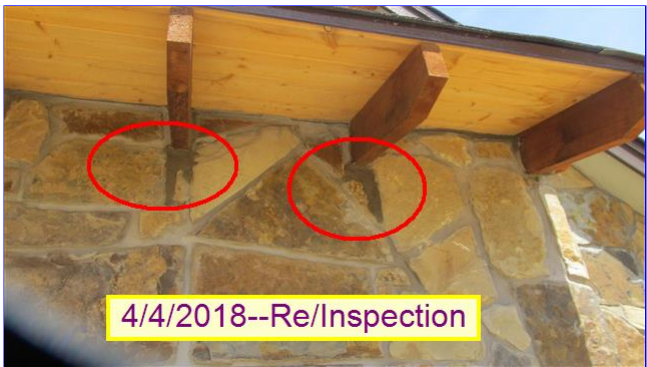
E. Item 16(Picture)

(6) Missing, Cracked and Damaged mortar and wood studs showing at front of home above master bath window. Recommend repair by qualified mason to prevent water intrusion or insects entering wall.

Mortar had been repaired.

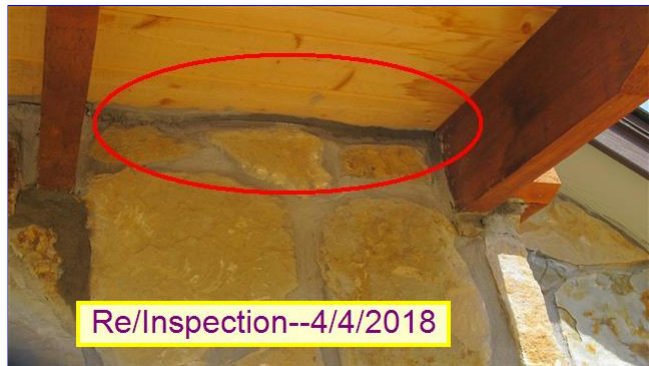
E. Item 18(Picture)

(7) Large gap at stone veneer siding and soffit above master bath window. Recommend repair by qualified contractor to prevent water or insect intrusion.

Mortar had been repaired.

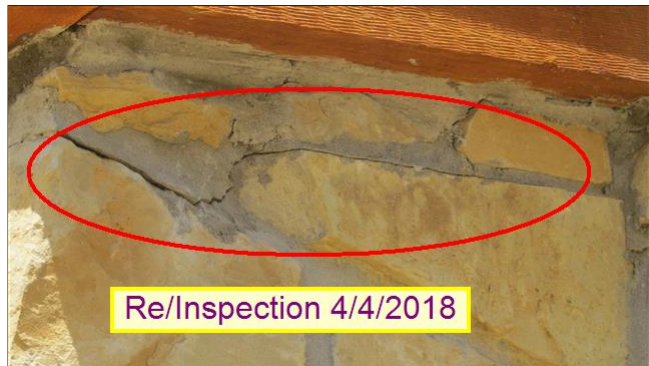
E. Item 20(Picture)

(8) Stone exterior siding mortar crack at right side (facing front) at corner. Recommend repair by qualified mason.

There was still a crack in the mortar. Recommend repair.

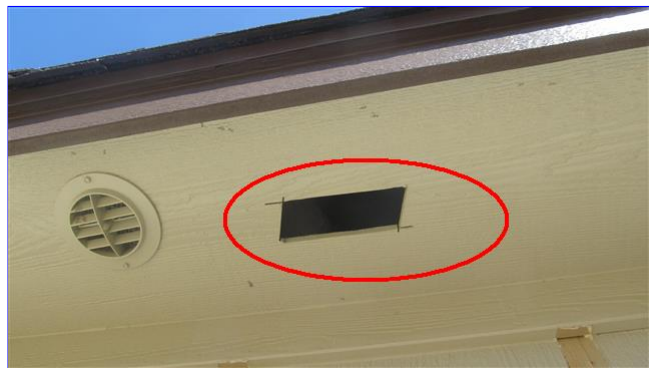
E. Item 22(Picture)

(10) The soffit panel at eave on the front of home at garage damaged. Repairs are needed. A qualified person should repair or replace as needed.

Hole had been repaired.

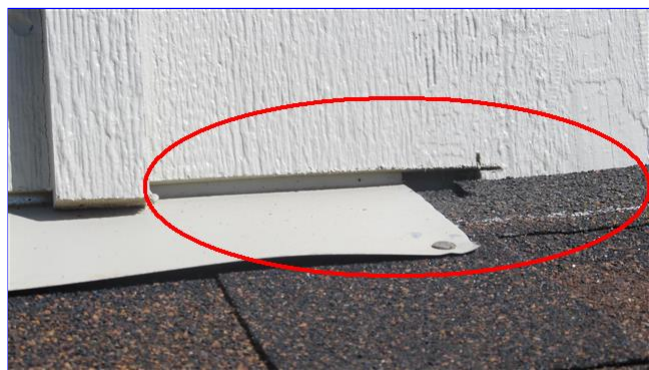
E. Item 23(Picture)

(11) There is a gap between the lower roof overhang at the garage window and the exterior wood siding. The flashing also does not extend all the way across the width of the overhang. This could cause moisture to get into wall and needs repaired.

It appeared the area had been repaired. Inspector was unable to see any areas that would allow moisture intrusion.

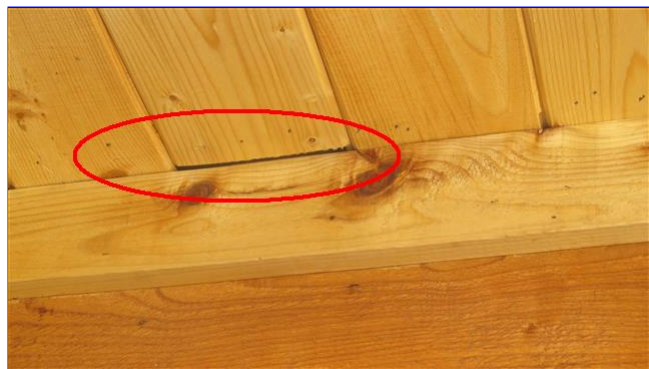
F. Item 1(Picture)

(1) The wood ceiling board at the front covered porch does not extend all the way to the trim causing a gap. Recommend repair or replace by qualified person.

This area still had not been repaired.

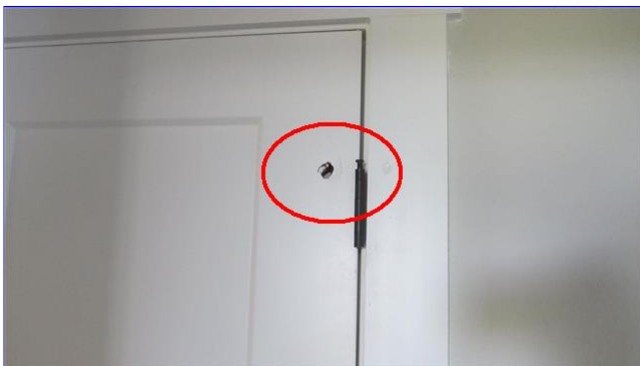
G. Item 6(Picture)

Inspector located hallway linen closet door damaged. This door will need to be replaced.

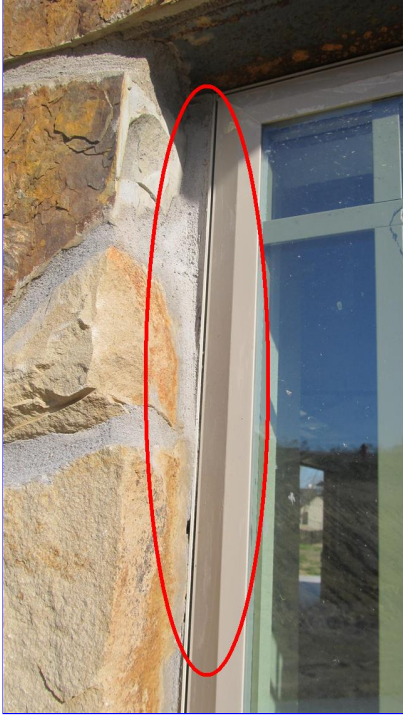
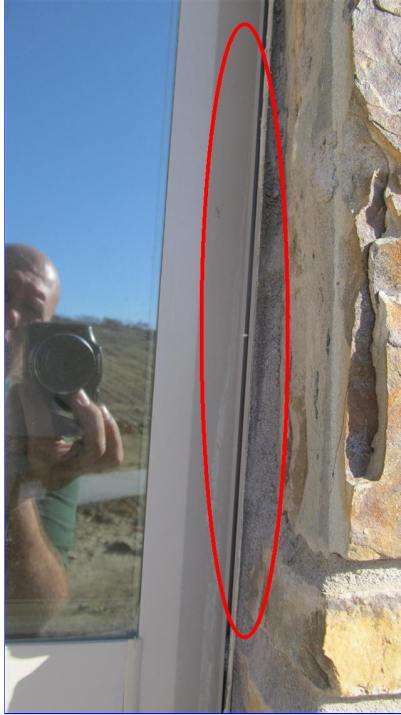
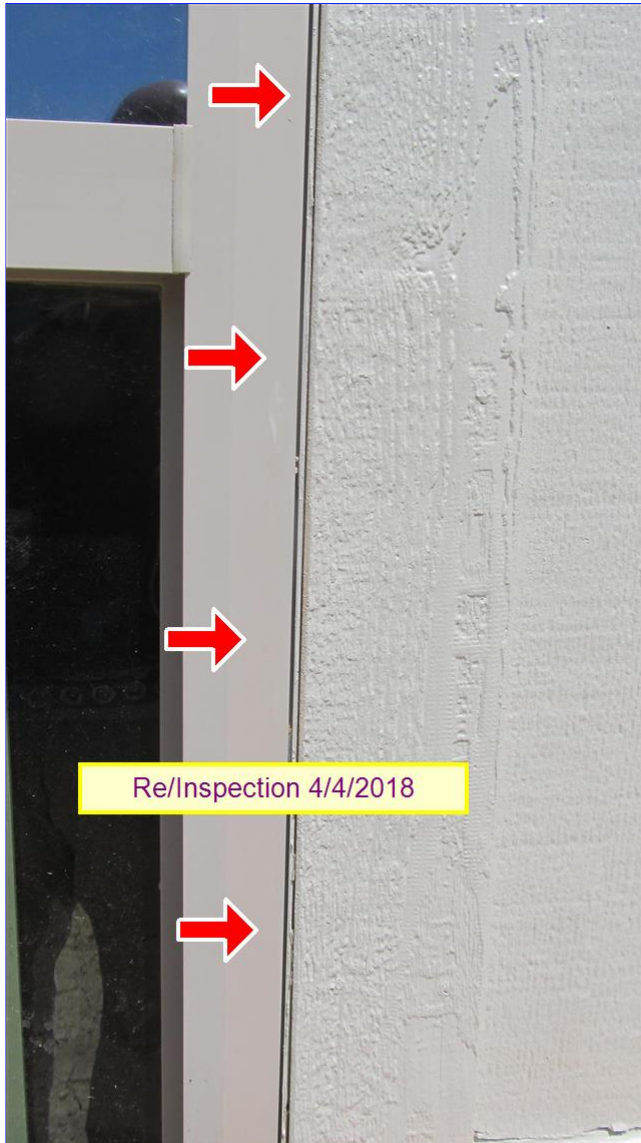
Exterior windows had still not been caulked. Worker at jobsite said that they would be done this week.

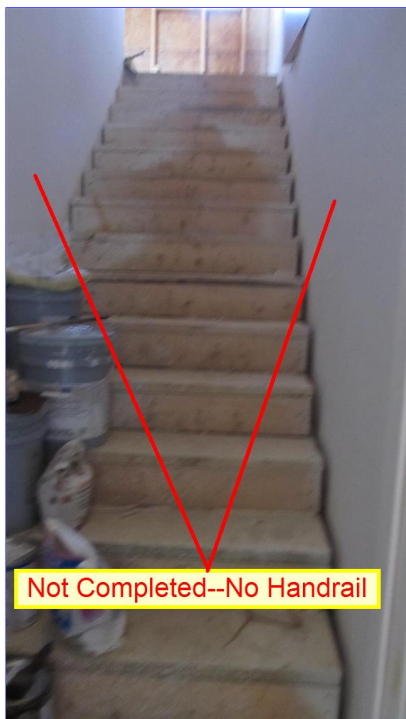
I. Item 1(Picture)

The stairway leading to bonus room above garage still did not have handrails and was not complete. **Recommend handrails be installed for safety.**

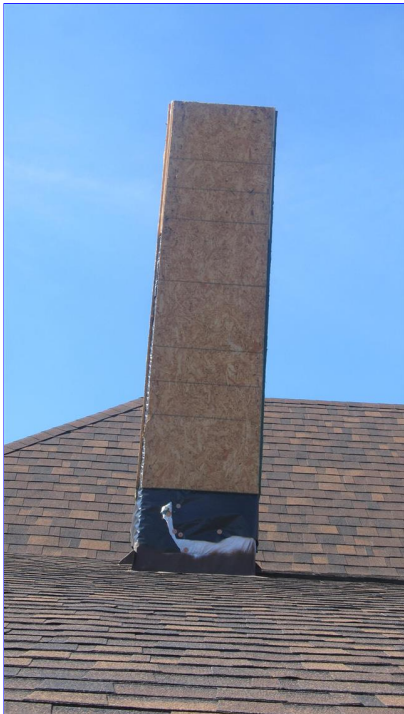
J. Item 1(Picture)

The Chimney had been constructed but still did not have a cap or screen. **Recommend cap and screen be installed.**

The Fireplace had been completed but the gas line for gas log starter was not completed and could not be tested.

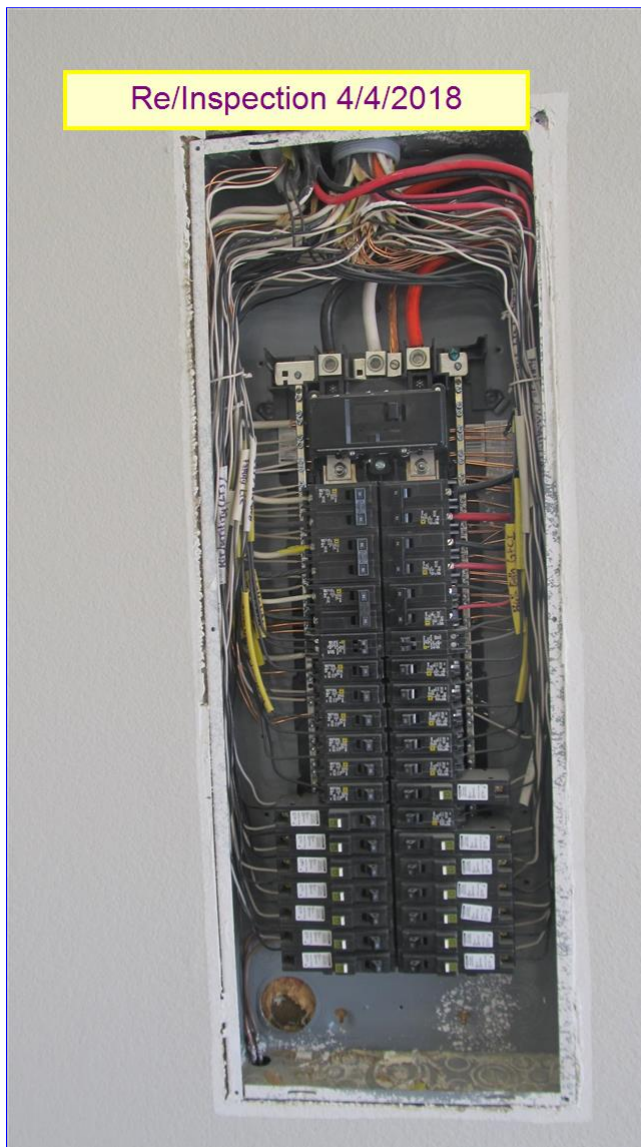
A. Item 8(Picture)

(2) I cannot locate a ground wire and ground rod for meterbase. This is considered unsafe. I recommend a ground wire and rod be installed on meter base by a qualified electrician.

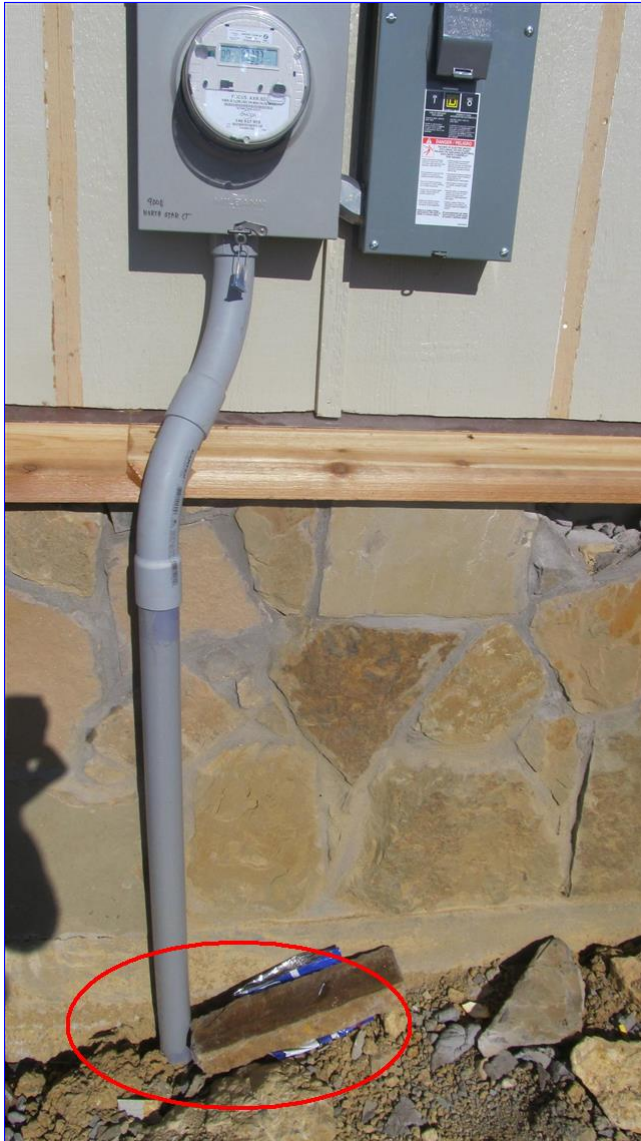
A. Item 9(Picture)

(3) Ground wire at main panel not attached ground rod.

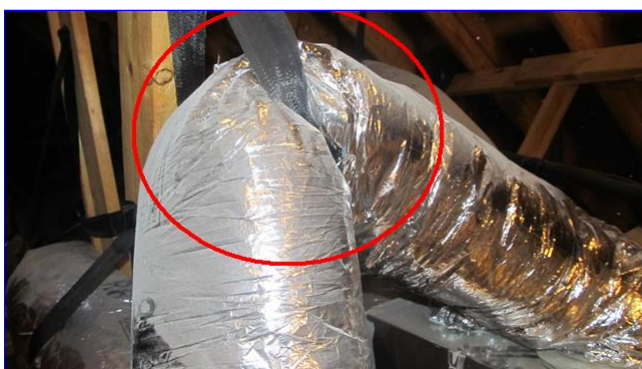
C. Item 1(Picture)

While some supports were repaired, there were still some flex ducts that were pinched and would cause restricted flow. These need to be repaired.

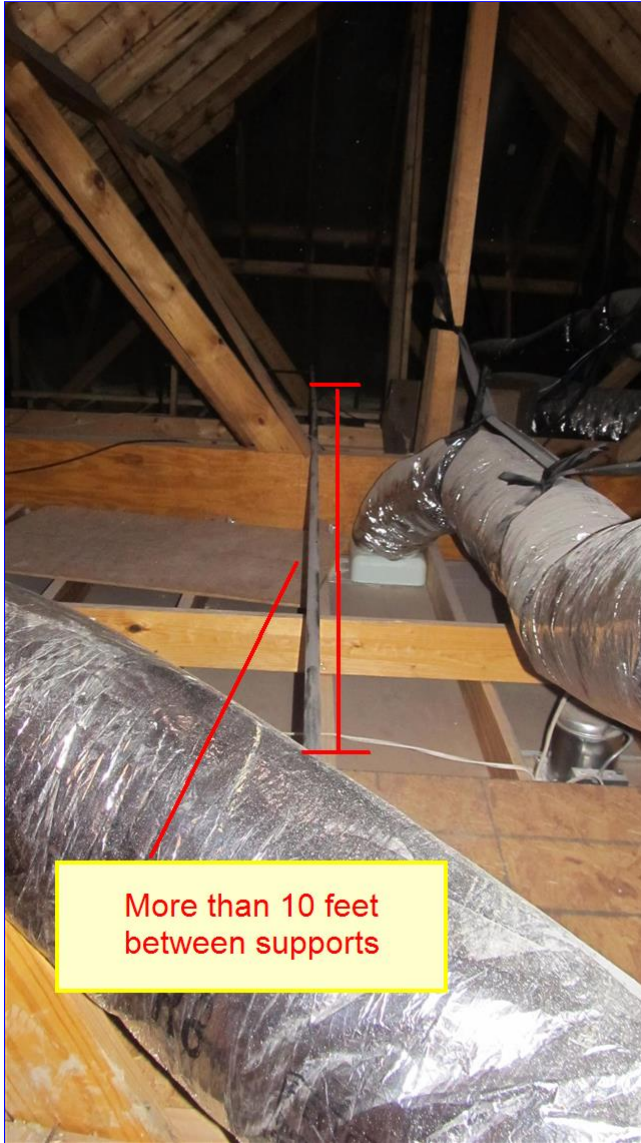
B. Item 1(Picture)

Steel Gas piping in attic was still supported by 2 X 4s and there were spans of over 10ft without supports. This is not up to today's standards. A licensed plumber should evaluate and repair with suitable and adequate supports.

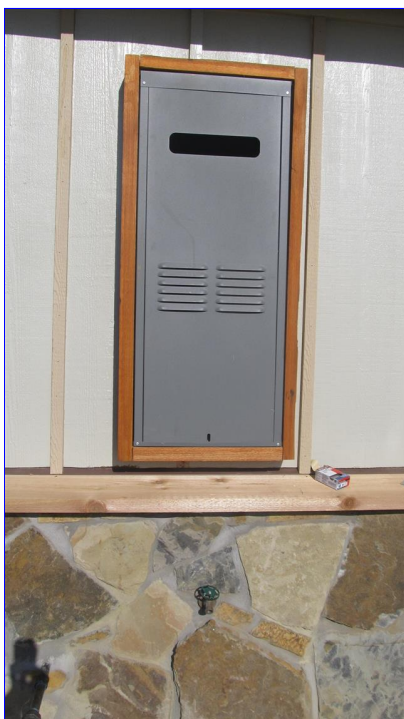
D. Item 1(Picture)

Tankless Water Heater was not completely installed and was not operational.

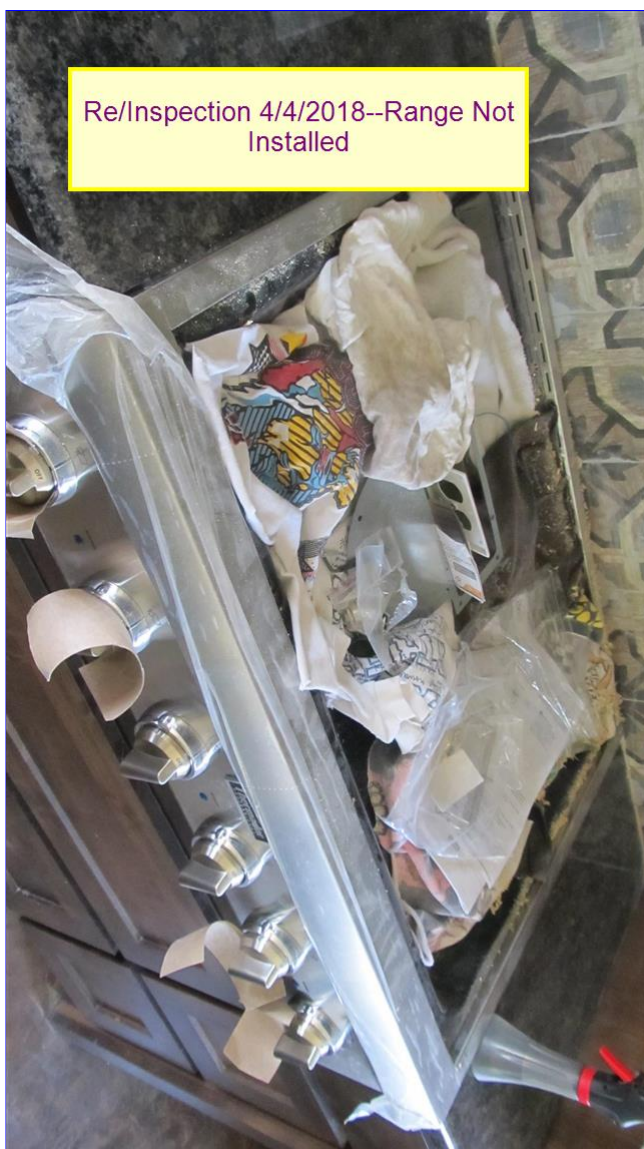
D. Item 1(Picture)

The Range (Thermador) had not been fully installed and was not tested.
