Inspection Report

New Construction Home

PROPERTY INSPECTION REPORT

Concerning: New Construction

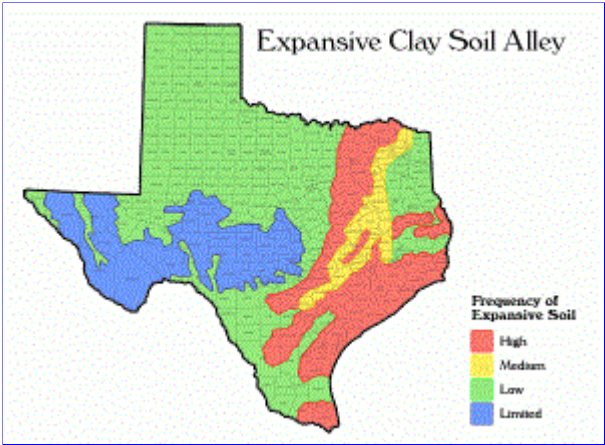
A. Item 1(Picture)

(1) Notice: Highly plastic clay soils, as are typically found in this region, exhibit a great amount of expansion and contraction with varying moisture contents. Because of this fact, watering your foundation is very important and establishing a regular watering program to keep the soil around the foundation at a constant moisture level will help control movement in the soils around and under the foundation. With the probability of this type of expansion and contraction of the soils, slab on grade homes and traditional/ modern pier and beams homes will experience some degree of foundation distress. You should expect to see deflection cracks in the exterior brick veneer, interior sheetrock cracks and floor tile cracks.

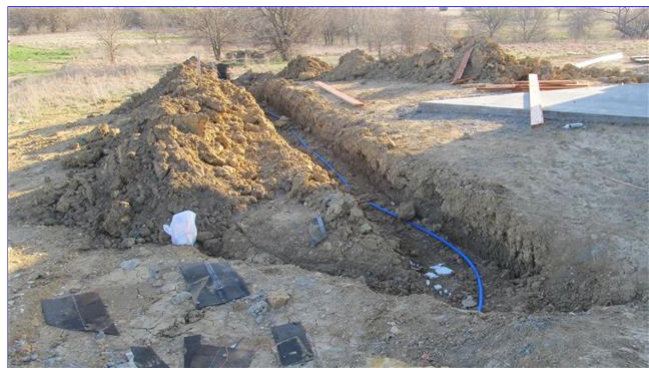
B. Item 2(Picture)

(1) At the time of the inspection, the grading was not completed for front or back yard and water supply line and electrical conduit for rear electric was not covered. Recommend a re-inspect after final grading and drainage is complete.

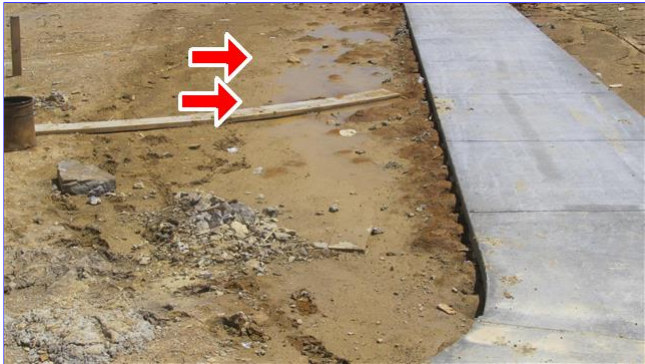
B. Item 4(Picture)

The final grading was still not completed at the time of the inspection. Inspector observed dirt silt on front walkway and areas that had water from last rain. These areas may need additional drainage such as french drains to prevent excessive moisture around foundation and erosion.

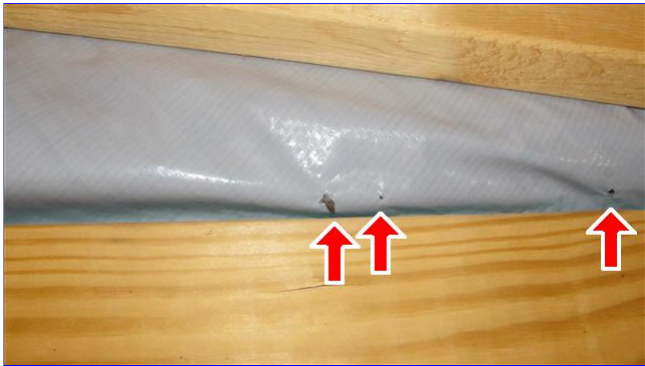
C. Item 8(Picture)

(2) The roof moisture barrier at the top of the valley above the garage had roofing nail hole. The inspector is not able to tell if this condition will cause a leak due to no rain. Recommend monitor area and repair if needed.

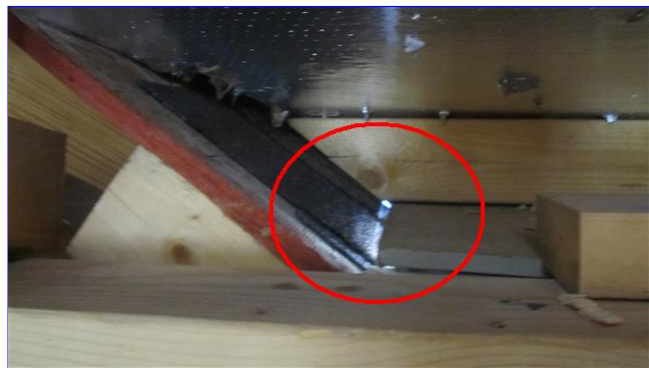
D. Item 1(Picture)

(1) Located 2 areas of the roof structure with gaps exposing the attic to moisture intrusion and had missing flashing. Areas were at the rear of home over the garage. The builder was at the home during the inspection and said that he was aware of the issue and the gaps would be repaired. The construction for these areas appeared to also be a change in the original plans for the home which changed the roof design.

Area of concern had been corrected with insulation and flashing.

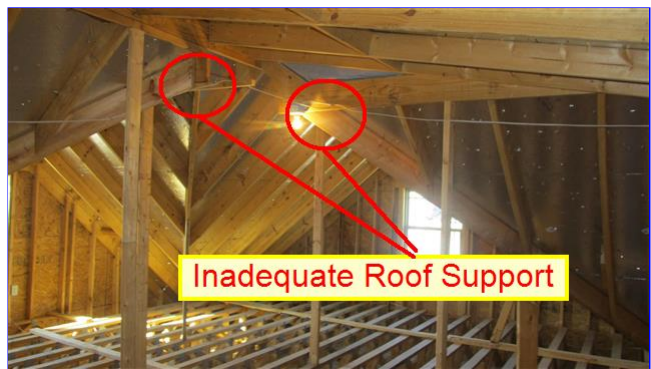
D. Item 6(Picture)

(2) There are areas of the bonus room (upstairs) where the roof design was changed which caused the rafters to not have adequate support. These areas will need additional support beams and columns to prevent a structural failure. Recommend a qualified construction contractor evaluate and repair area for support.

The Rafters in this area were still unsupported and may not hold the weight of the roof valleys. This area should be evaluated by a structural engineer.

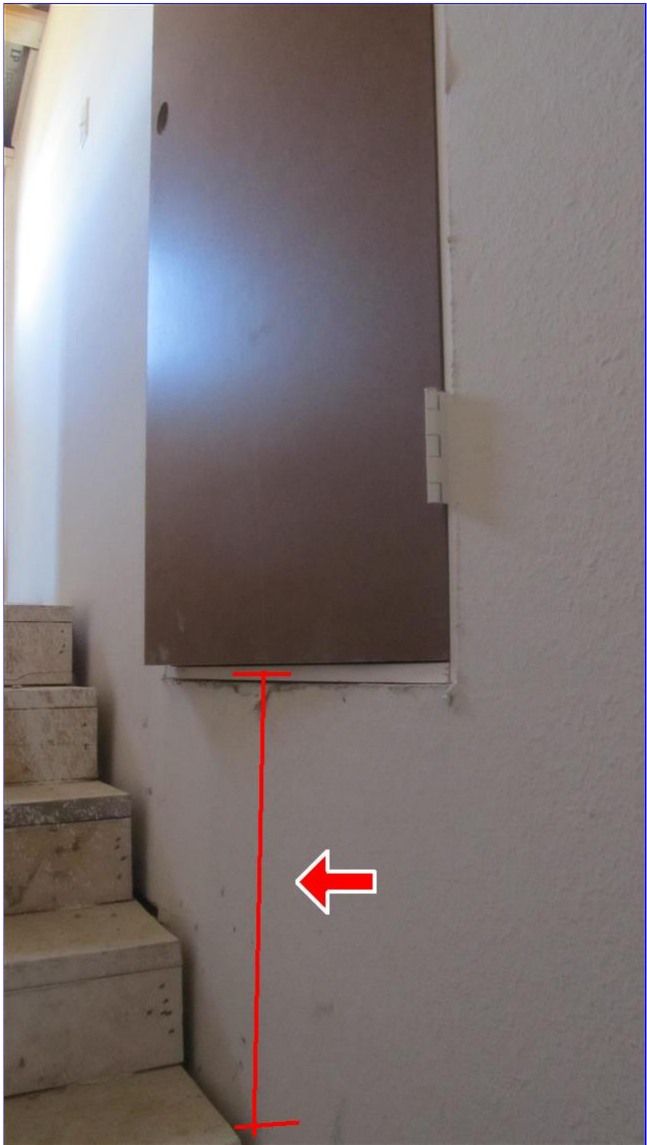
D. Item 10(Picture)

(3) The attic access door in unfinished bonus room (at upper level) does not allow reasonable access (over stairs). Injury could result if not repaired. A qualified contractor should inspect and repair as needed.

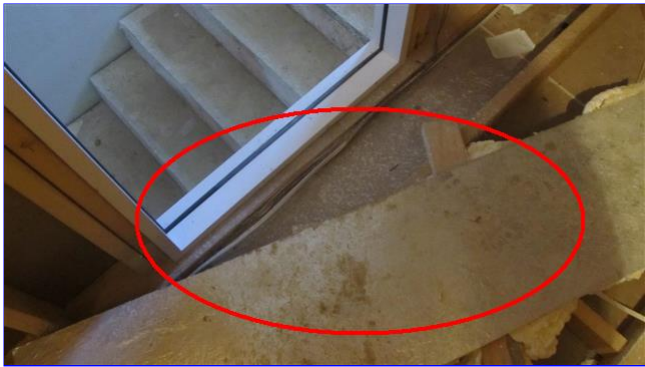
D. Item 13(Picture)

(4) The attic passageway (platform) to furnace and HVAC air handler is not finished and is a hazard. Recommend the platform be extended all the way to the edge of the attic access door.

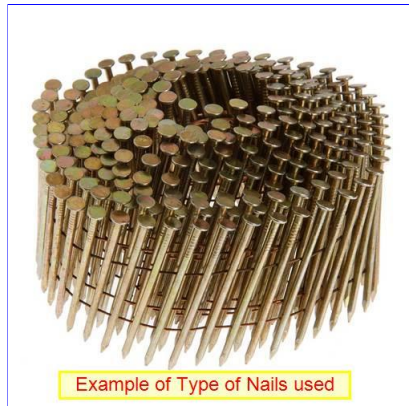
E. Item 5(Picture)

(3) The vertical wood siding was fastened with what appeared to be wood and cement fiber stainless steel

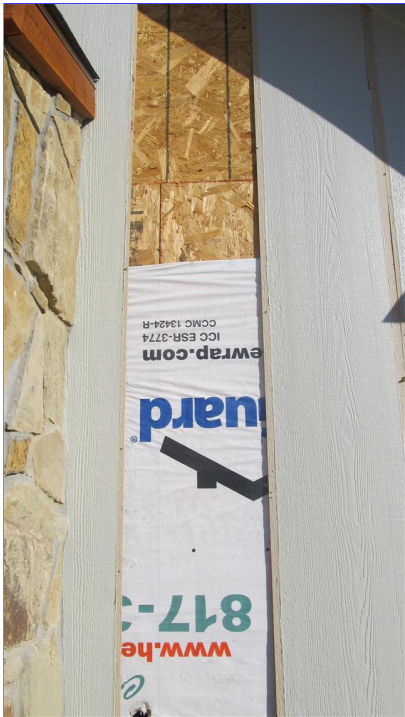
E. Item 12(Picture)

Exterior Siding had been installed properly.

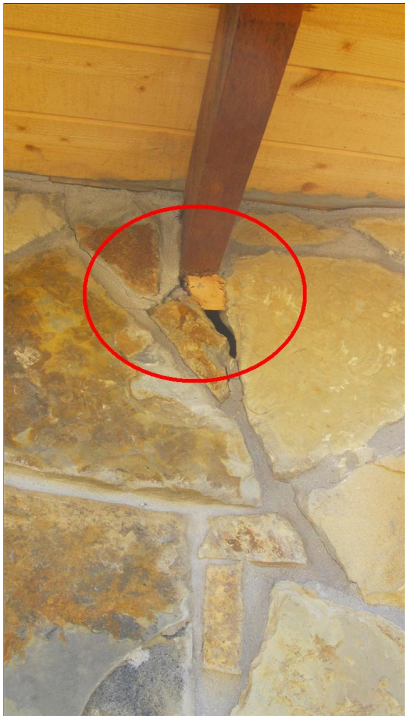
E. Item 13(Picture)

(6) Missing, Cracked and Damaged mortar and wood studs showing at front of home above master bath window. Recommend repair by qualified mason to prevent water intrusion or insects entering wall.

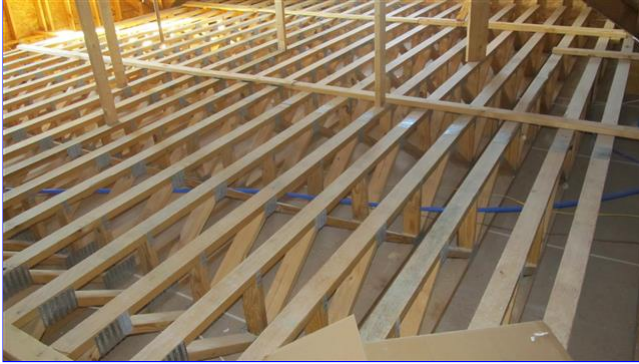
F. Item 5(Picture)

(3) The subfloor was not completed at the time of the inspection in the upstairs bonus room. For safety, this area should not be used or accessed until floor is finished.

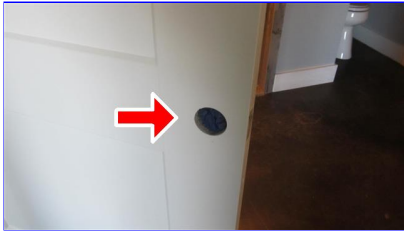
G. Item 1(Picture)

Some doors still did not have hardware installed and were not finished.

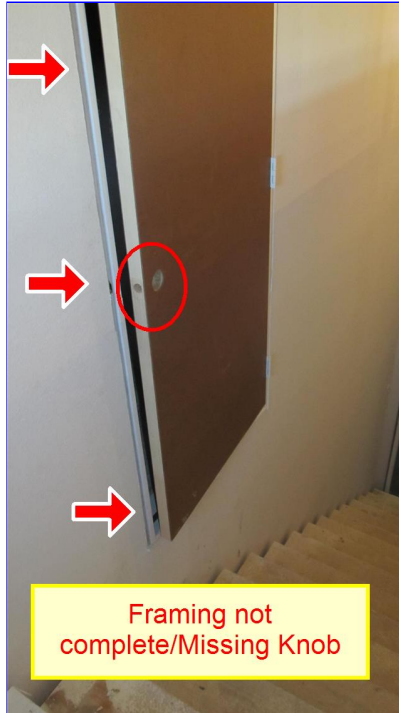
G. Item 2(Picture)

(1) Several doors were not complete (missing knobs, locks missing, frame not completed or not painted). These items will be re-inspected at a later date TBD.

Inspector located hallway linen closet door damaged. This door will need to be replaced.

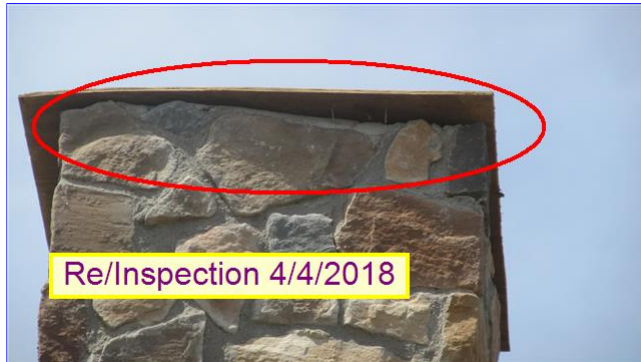
J. Item 2(Picture)

The Chimney had been constructed but still did not have a cap or screen. **Recommend cap and screen be installed.**

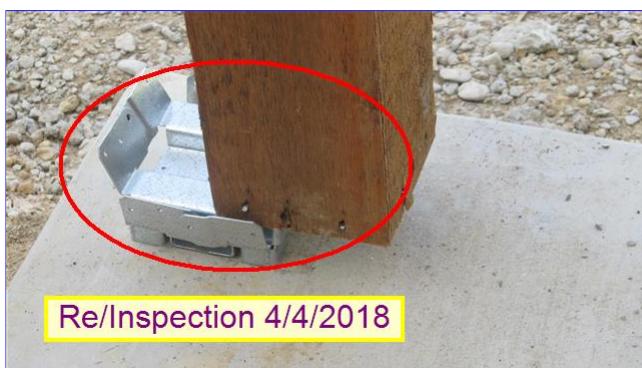
K. Item 1(Picture)

The rear covered porch cedar support beams had wood footing which would be prone to rotting causing the beams to be unstable. Recommend installing metal footings that are attached to concrete.

At the time of the inspection, workers were installing metal footings.

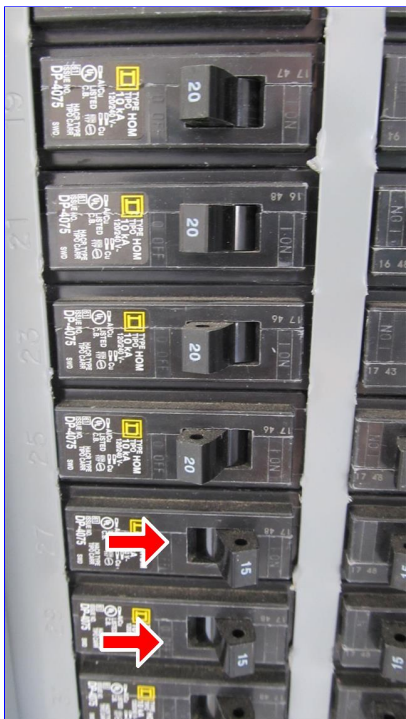
A. Item 1(Picture)

(1) Several breakers were turned off at the time of the inspection. Several interior and exterior outlets were not operational as a result. Mostly kitchen, bathroom and garage outlets as well as some exterior and interior light fixtures. The inspector did not turn on breakers due to the possibility of unfinished construction and possible fire or shock hazard. These items will be re-inspected at a later date TBD.

Breakers were on and working properly.

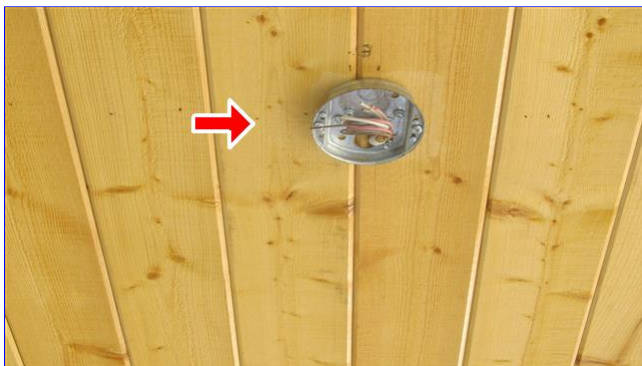
B. Item 1(Picture)

Several exterior and interior fixtures had still not been installed.

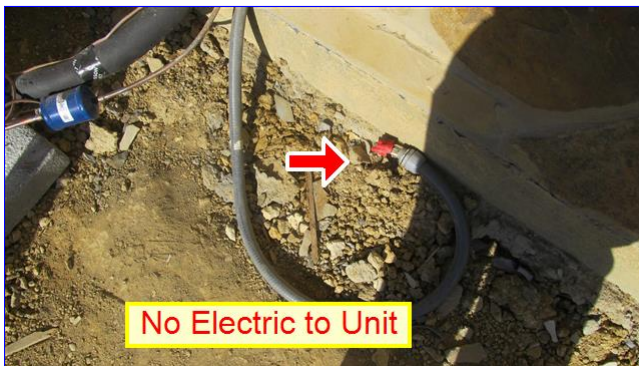
B. Item 1(Picture)

Unit was operational and working properly.

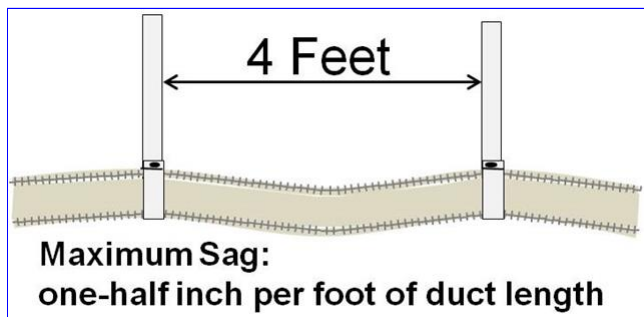
C. Item 2(Picture)

Improper spacing for flex duct supports (some over 4 ft) in the attic and at least one duct was pinched which would cause a restricted airflow. These items need to be repaired properly by a qualified HVAC tech.

While some supports were repaired, there were still some flex ducts that were pinched and would cause restricted flow. These need to be repaired.

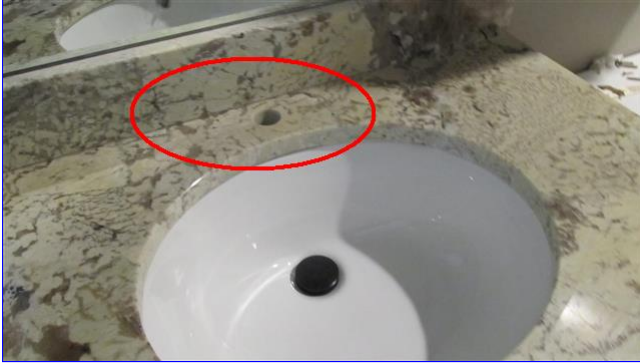
A. Item 1(Picture)

All fixtures had been installed and were working properly except the Master Bath Claw Tub had still not been installed and was not evaluated.

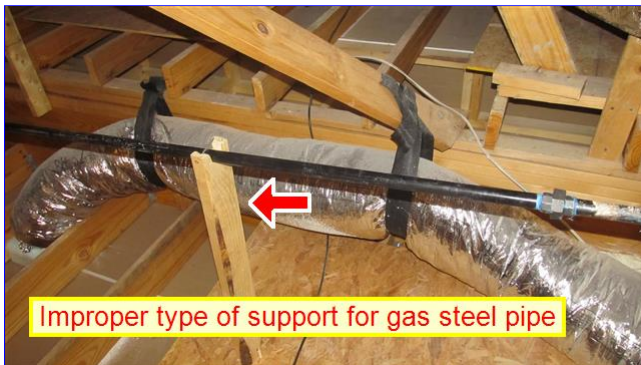
B. Item 2(Picture)

Improper spacing of gas steel pipe supports in attic area as well as improper type of supports used (Wood). Recommend repair and/or replace supports to code requirements.

Steel Gas piping in attic was still supported by 2 X 4s and there were spans of over 10ft without supports. This is not up to today's standards. A licensed plumber should evaluate and repair with suitable and adequate supports.

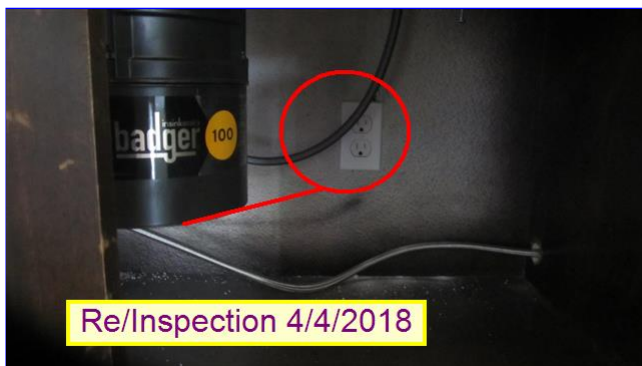
B. Item 1(Picture)

The food waste disposal had not been completely installed. The electrical cord still needed to be attached for it to operate. This item was not tested.
